Manhole Inspection Summary

Manhole # S25I__011MH

Insp Date: **3/17/08 1:36 PM**

Location Address: **alley behind 120 S.STOCKTON ST.** Cross Street: **north of W.PRATT ST.**

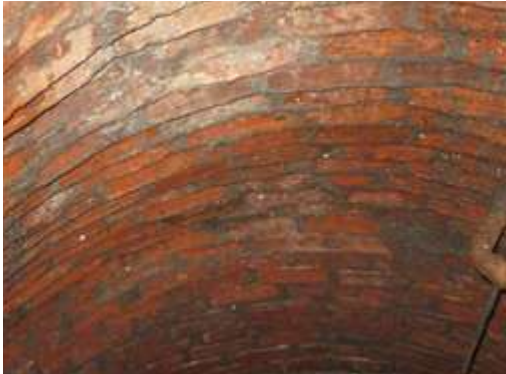
MUD DEPOSITS ON CORBEL WALL

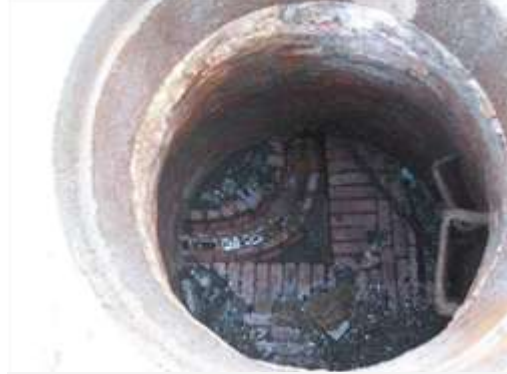
Top View

Misc. bench debris

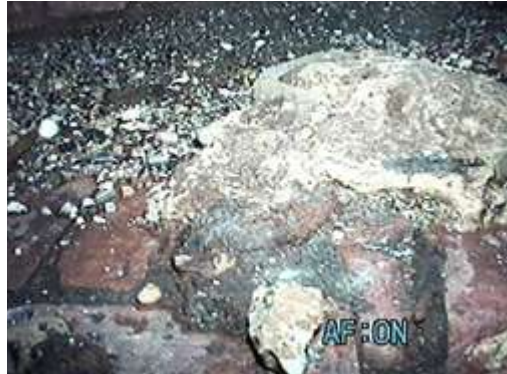
DEBRIS ON BENCH

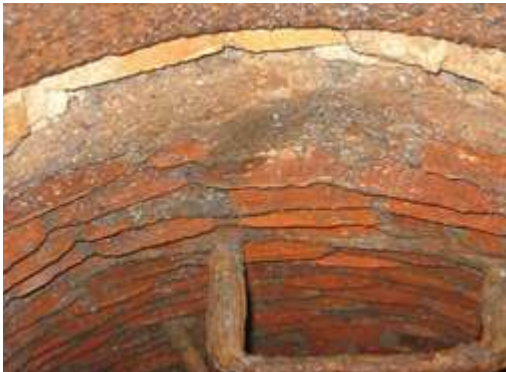
Defect 2

Condition: ☐ Sound ☐ Cracked ☐ Root Intrusion ☐ Loose Brick ☒ **Deteriorated**

Infiltration: ☐ None ☐ Joint ☐ Cracks ☒ **Mortar** ☐ Roots ☐ Wall

MISSING MORTAR WITH EVIDENCE OF INFILTRATION AT THE CHIMNEY, CHIMNEY DETERIORATING

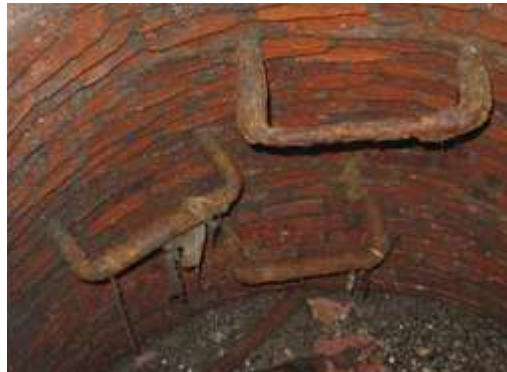
Defect 1

Steps Count: **3** Missing: **0** ☒ **Corroded**

Surcharge ☒ **Evidence Of Surcharge** Depth: **3** (ft.) ☐ Active Surcharge Present

CORRODED STEPS WITH EVIDENCE OF SURCHARGE

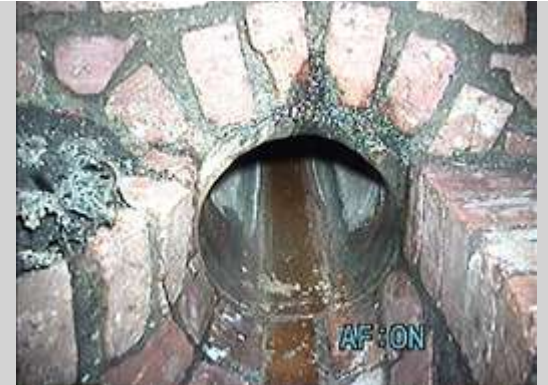
12 O'Clock Outflow

Pipe Height: **8.4** (in.) Rod and Bar (Angled)
Pipe Material: **Clay** ☐ Pipe Lined
Invert Depth: **7.12** (ft.) Flow Characteristics: **None**
Deposits: ☒ None ☐ Mud ☐ Sludge ☐ Debris ☐ Grease
Silt Depth: **0** (in.) Deposits Extent:
Infiltration: **Evidence** Pipe Seal Cond: **Sound**

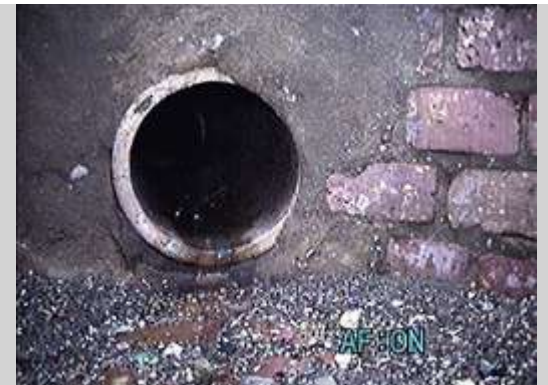
6 O'Clock Inflow

Comments **6 oclock pipe connection is attached to "dead end" coming in at bench level.**

Connects To: **Dead End**
